# Fort Bruere 'Ill laid out and wers Executed.' Archaeological Investigation at Bermuda's Last Homegrown Fort

John R. Triggs, PhD  
Associate Professor,  
Department of Archaeology and Classical Studies,  
Wilfrid Laurier University,  
75 University Avenue W.,  
Waterloo, Ontario, Canada N2L 3C5

*ABSTRACT: The close of the American Revolution signalled the beginning of Bermuda's role as a naval dockyard and it was at that time that plans were made for strengthening island defences. While there are many surviving examples of 19th-century fortifications, there are fewer remains of older permanent fortifications and even less is known of the impermanent field positions constructed by the local population. Fort Bruere, a small fascined fort on a hilltop in Tucker's Town, is one such fort for which little is known historically and for which archaeological excavation has the potential to provide additional information on what is one of the last truly Bermudian forts. Archaeological and documentary research serves to identify the site as a unique surviving example of a rare type of Bermudian fortification undeserving of its contemporary description. In a larger perspective the investiga

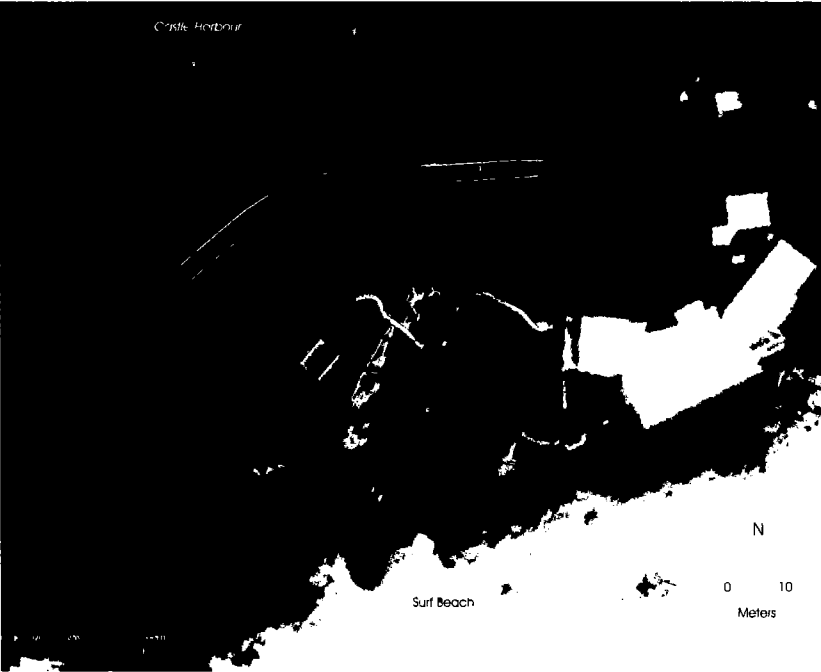
*Fig. 2: Aerial view with surveyed features*

Fort Bruere sits atop the highest outcrop on Tucker's Town peninsula. At an average elevation of about 25 metres above MSL (Fig. 2) this position served the strategic role of providing a landward defence for the Castle Island fortifications, and also to cover the small bays on both the seaward and harbour side of the peninsula. As noted above, the earliest surviving account of the fortification is by Simon Fraser in 1783 who described the fort as having been constructed of fascines. In the same year, Andrew Durnford further related that these fascines had been raised so high as to allow an opposing force to advance below the line of fire. These early descriptions have proven useful in interpreting existing archaeological features at the site. During a visit in 1994, Edward Harris and Norman Barka noted a linear distribution of small rubble along the west side of the hilltop and following the natural curve of the hill on the south side.<sup>11</sup> In 2005, prior to excavation in this area, the same distribution was visible, although partially obscured by vegetation. After clearing vines and undergrowth it became evident that the stones followed the upper contours of the hill, suggesting that these may represent vestiges of the original 'fascined fort' referred to by Fraser and Durnford.

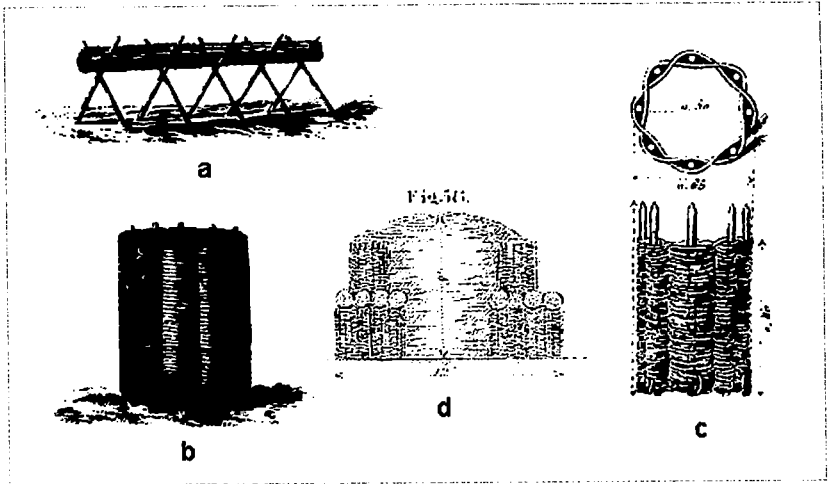
Fig. 6: Various depictions of fascines and gabions: (a) gabion from Joshua Jebb Sieges Duties Plate VII, 1857; (b) gabion from J. Laisne Aide-Memoire Portatif Chapter VIII Plate 1, 1837; (c) gabion from Joshua Jebb Sieges Duties Plate VII-02, 1857; (d) gabions and fascines from Mahan, D. H. A Treatise on Field Fortification, Fig. 58, pp. 59, 1861

Fascines, most commonly associated with field fortifications in a military context, are bundles of brushwood (1–2 ins diameter) of varying length (6–20 ft depending on the availability of material), tightly bound together with wire or withes (Fig. 6a).<sup>12</sup> These were often

combined with gabions—wicker baskets about 2 ft 9 ins to 3 ft in height and about 2 ft diameter (Figs. 6b, 6c)—which when placed vertically and filled with earth, could be combined with horizontally-laid fascines to create a parapet (Fig. 6d).<sup>13</sup> In the case of Fort Bruere, the absence of compactable earth in the area appears to have prompted the substitution of stone rubble as fill within the wicker baskets. If so, it is thought that the line of stones visible on the ground surface along the brow of the hill may represent the original fascined work, which has deteriorated *in situ* and which has not been disturbed for more than two centuries.

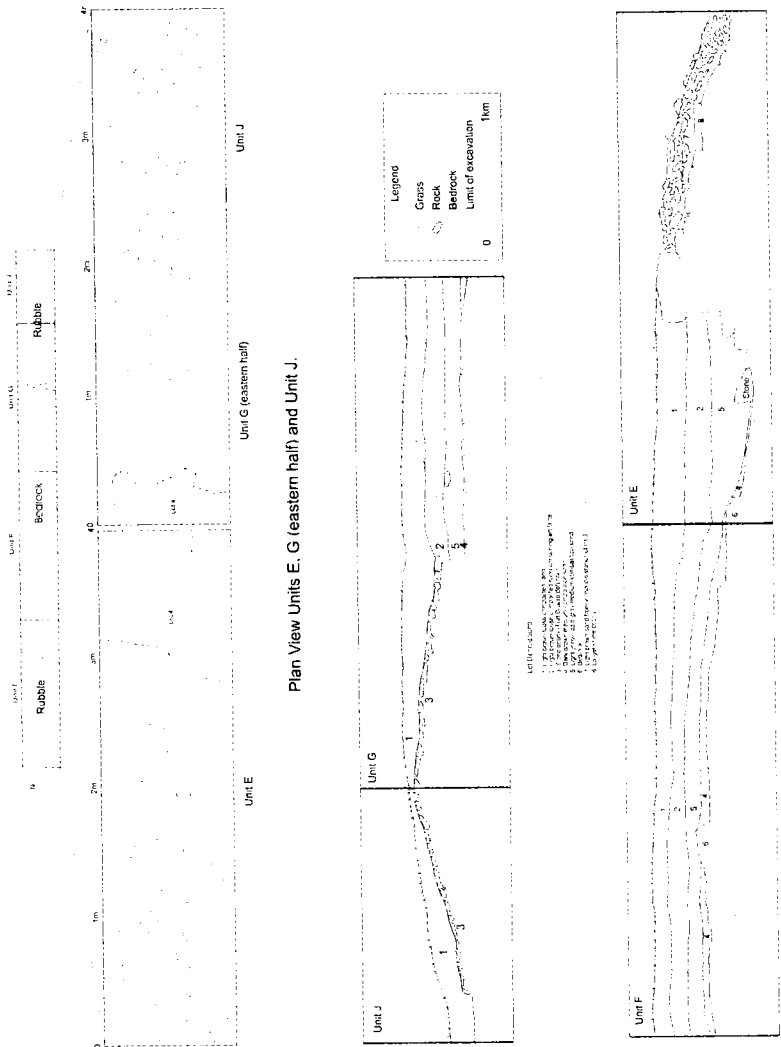
Fig. 8: Profile and plan views of the Fort exploratory trench

To investigate this feature, a 14 x 1m trench was laid in running in an east-west orientation across the hilltop intersecting the east and west edges of the hill at an oblique angle [Units E, F, G, and J]. Over a period of several days excavation in this area confirmed the hypothesis that the stones were indeed related to the fort. Definable distributions of rubble were found in both ends of the trench separated by an expanse of bedrock floor with virtually no rubble present (Fig. 7). At the west end of the trench, where stones were first visible on the ground surface, excavation revealed that the deposit was over one metre in depth with smaller-sized stones overlying a bedding of larger stone rubble. Although the line of stones was intersected at an angle, the linear distribution was approximately two to three metres wide. At the east end of the trench, excavation revealed a similar line of rubble which was not visible prior to excavation and which was buried only a few centimeters below the surface (Fig. 8). These also defined a linear feature about three metres in width. Both lines of stones at each end of the trench were separated by a distance of about six to seven metres in which only a few, isolated larger stones were found on top of the natural bedrock below the sand fill. The natural bedrock floor was exposed below about 60 cm of sand that had presumably collected in the 'trap' formed by the two adjacent lines of stone on opposing sides of the hilltop.

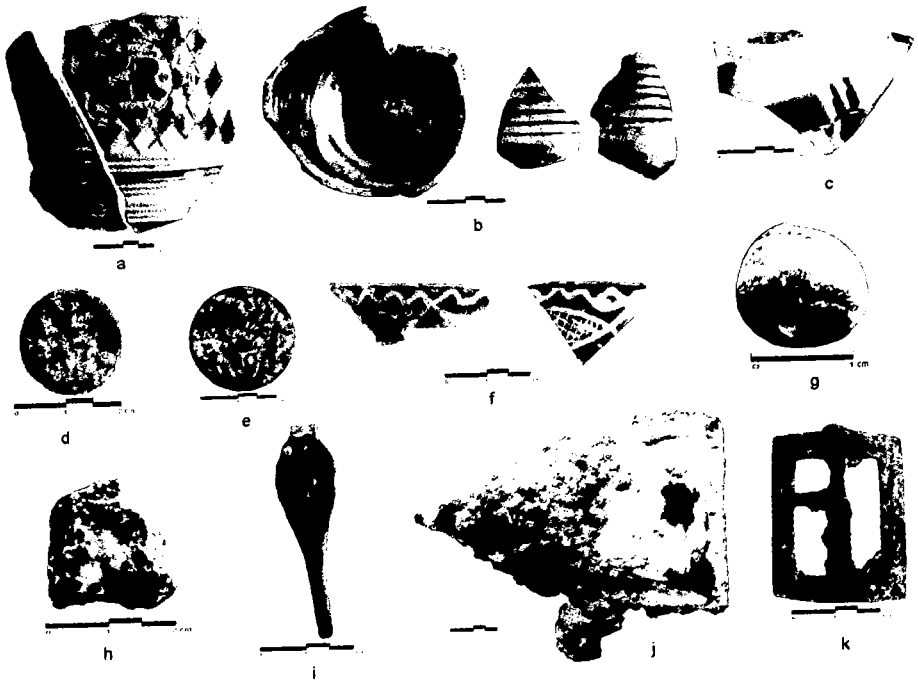
*Fig. 9: Selected artifacts recovered from various units: a) Rhenish stone-ware with 'GR' armorial pattern [Kitchen midden]; b) Bristol slipware [barracks/cookhouse]; c) painted tin-glazed earthenware [fort]; d) Royal Provincials regimental button, pewter [barracks/cookhouse]; e) 80th Regiment button, pewter [barracks/cookhouse]; f) etched stemware glass (shaded blue for emphasis, original is clear) [kitchen midden]; g) wire-wound blue glass 'Dutch' bead [magazine]; h) honey-blonde gun flint [fort]; i) trigger guard from pistol [barracks/cookhouse]; j) flat iron [fort] (k) brass buckle [cookhouse/barracks]*

artifact class that is most temporally diagnostic is ceramics. Importantly, dates provided by the ceramic assemblage as a whole support the two 'button-dates.' Many of the waretypes and decorative types recovered were popular in the middle decades of the 18th century (Table 2). The latest types recovered, creamware and pearlware, provide a *terminus post quem* for the deposit of 1760 to 1780. However, earlier ceramics such as tin-glazed earthenwares, common in the middle decades of the 18th century, predominate in the assemblage and point to the use of older, outmoded ceramics by the occupants. Several varieties of earthenware and stoneware also provide information on socio-economic status of the ceramic users and broader information on 18th-century ceramic supply in Bermuda. For example, the sample of Chinese export porcelain had a significantly higher purchase price than other, more common earthenwares such as tin glazed and lead glazed wares, pointing to its use by officers rather than soldiers. Also, the variety of waretypes recovered (Table 2) points to a ceramic supply originating in England. This stands in contrast to 17th-century sites in which a wide-ranging trade network involving several European countries is more usual.<sup>15</sup> Other high status items associated with officers include a trigger guard from a flintlock pistol, etched glass stemware, and a decorative brass clothing buckle (Fig. 9).

Further support for the function of the building as a kitchen is found in a midden deposit on the exterior of the structure in Unit L. Located on the southwest corner of the building, close to the proposed doorway location on the middle of the south wall (Figs. 19 and 20), a midden was found within a deep natural declivity in the bedrock adjacent to the west wall. Here, below almost two metres of windblown sand (Fig. 23), an assemblage of artifacts was recovered that dates to the 18th-century occupation of the building. Over 200 fragments of food bone, mostly fish, followed by almost equal numbers of bird and mammal, comprise the majority of artifacts found. Also of interest, are the shards of etched glass stemware and the Rhenish stoneware sherds that match samples found within the Barracks/Cookhouse. The Rhenish stoneware fragments mend to form a large section of an armorial pattern tankard with a 'GR' motif (Fig. 9). This probably denotes George II (*r.* 1727–60) rather

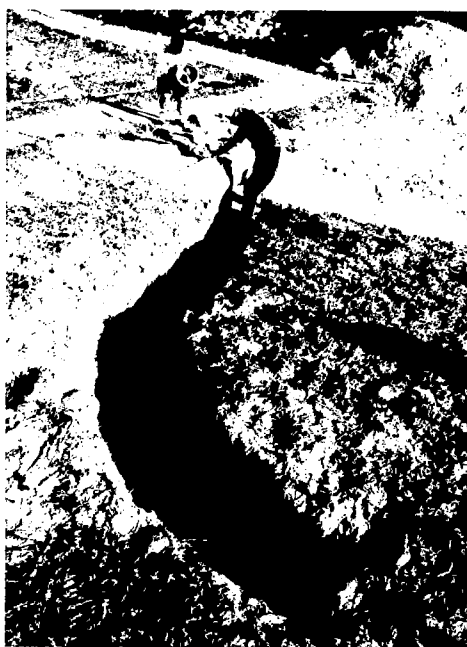
*Fig. 14: Excavating the passageway from the magazine to the Fort*

fort by way of a passageway leading from the face of the same cliff to the battery above (Fig. 14), its function seems obvious. More importantly, however, the covered position of the magazine at the base of the slope behind and below the battery itself, points to a well-conceived use of the natural landscape to which the fort and ancillary structures were adapted.

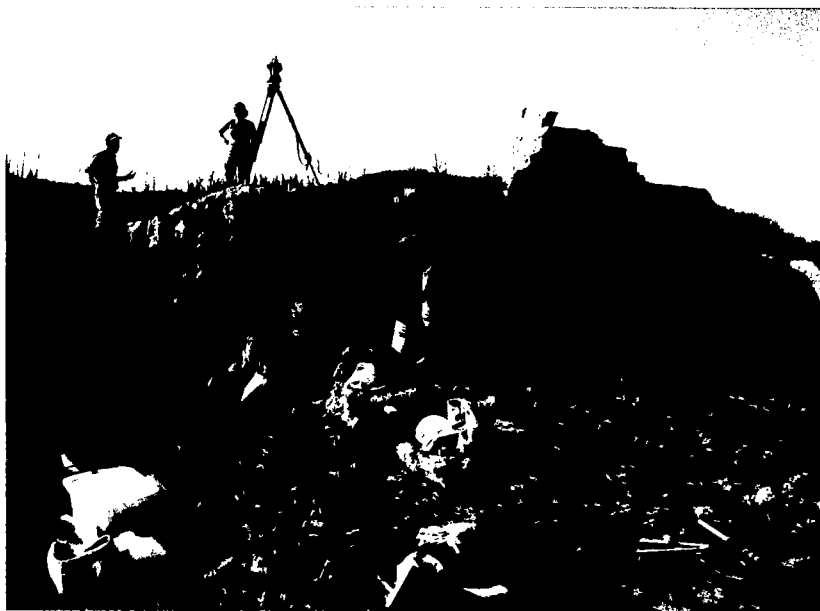
*Fig. 16: The Barracks/Cookhouse fireplace and area prior to excavation*

Evidence of this structure was visible prior to excavation as a masonry wall and fireplace built on top of a natural stone foundation that had been quarried out of the native bedrock (Figs. 16, 17). Prior to excavation, the presence of a fireplace suggested the structure may have represented a cookhouse/kitchen, although the date of the building and the association with Fort Bruere remained to be substantiated. Three test excavation units [Units A, B, and C] were placed on the inside of the structure adjacent to the north, west and south walls in an exploratory investigation aimed at determining the depth of deposit within the structure, date of construction, duration of use, and function. Based on the findings from these exploratory units, namely, that the depth of soil over bedrock was not substantial, a decision was made to excavate the entire interior of the structure in the time that remained.

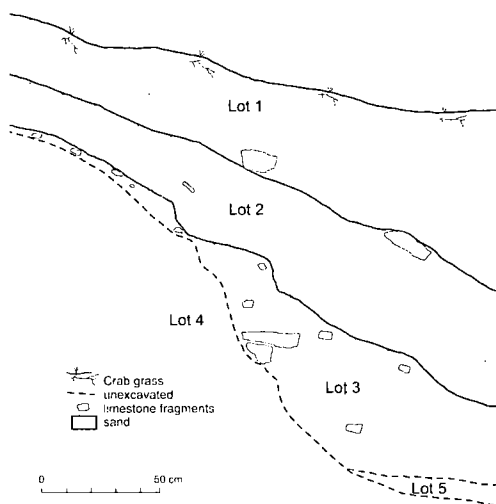
*Fig. 23: Unit L, the kitchen midden, east profile, showing the depth of fill over bedrock*
