Shoreline bluff failures: A GIS assessment of susceptibility and risk for Lake Erie's north central shore (Ontario)

Nathan Joel Badger
Wilfrid Laurier University

**Shoreline Bluff Failures:
A GIS Assessment
of Susceptibility and Risk for
Lake Erie's North Central Shore**

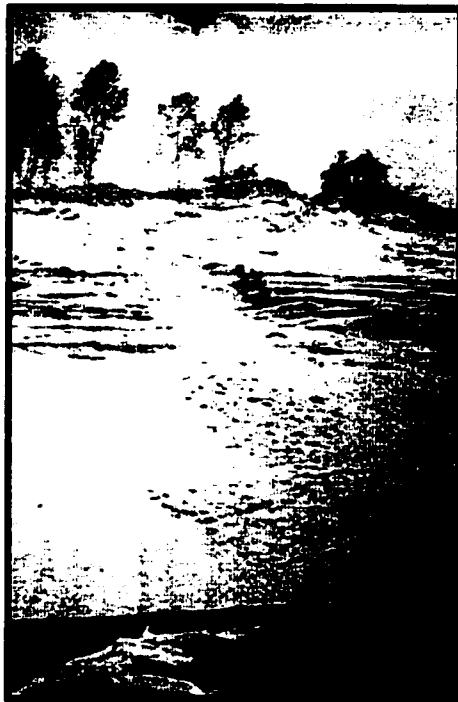
Figure 5.3g: Large sand flow at Sand Hills Park. Notice stratigraphy and small beach. Aeolian sand has been piled above the Norfolk Sand Plain which is evident in the middle of the flow back scarp.
