Destroying the Panthers: The Effect of Allied Combat Action on I./SS Panzer Regiment 12 in Normandy, 1944

Arthur Gullachsen

Gullachsen, Arthur "Destroying the Panthers: The Effect of Allied Combat Action on I./SS Panzer Regiment 12 in Normandy, 1944." Canadian Military History 25, 2 (2016)

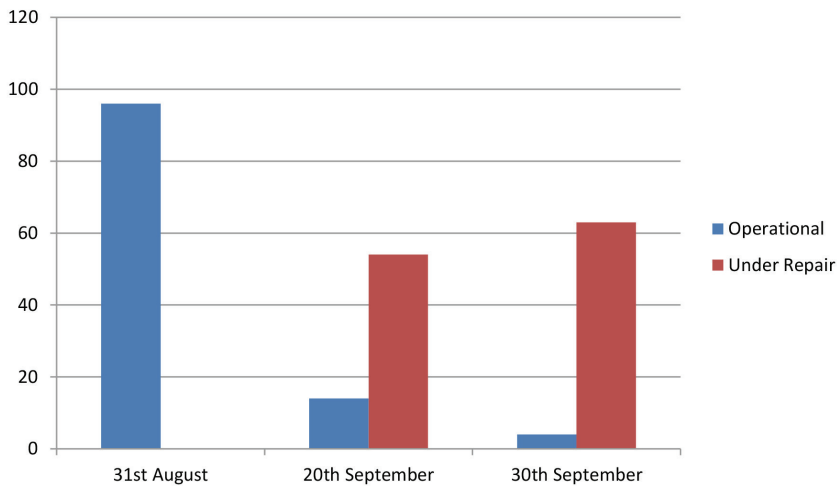
Chart 1: Number of operational Panthers versus those in repair for the 2nd battalion, 23rd Panzer Regiment in the Ukraine, August–September 1943. [Thomas Jentz, *Panzertruppen Volume 2*]

initially designed for a much lighter vehicle, and this increased weight led to the engine, transmission, and final drives being overstressed. Inadequate initial fuel pump and engine compartment design led to engine fires during the summer of 1943 which engulfed the tank. The first Maybach engine was also a weak link, with bearings and connecting rods that failed after a short period of time. A large number of tanks in the Panther battalions are recorded as sidelined due to these maintenance issues during the fall of 1943.¹¹ As illustrated in Chart 1, these figures are abysmal.¹²

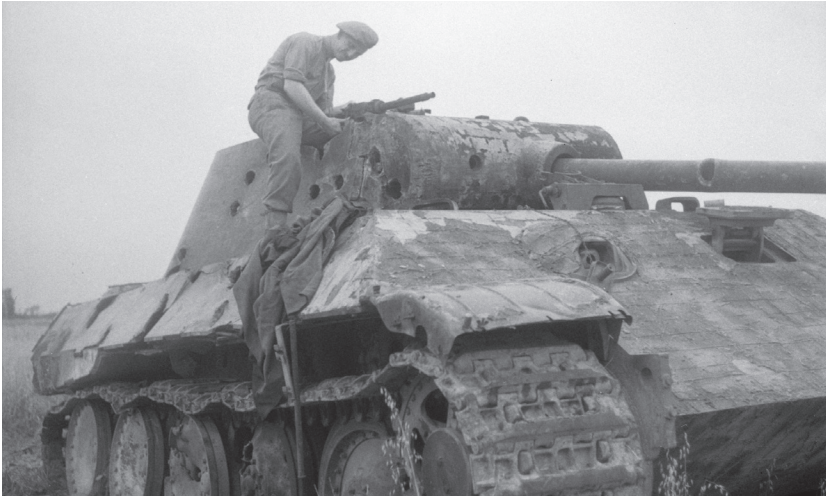
3rd Company SS Panzer Regiment 12 Mark A Panther destroyed near Norrey-en-Bessin, France on 9 June 1944 and later used as target practice. [Library and Archives Canada PA-130338]

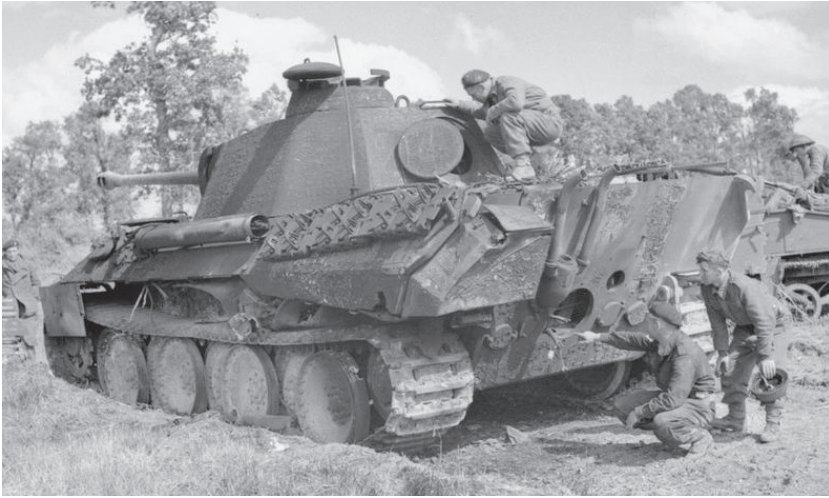
Destroyed 2nd Company SS Panzer Regiment 12 Panther Mark A being inspected by the Durham Light Infantry near Rauray, France, 27 June 1944. [© IWM (B 6046)]
